BrM Configuration and Bridge Data Validation

Jacob Armour, P.E.

Structure Program Division

BrMUG 2024 | Long Beach, CA | September 17-18

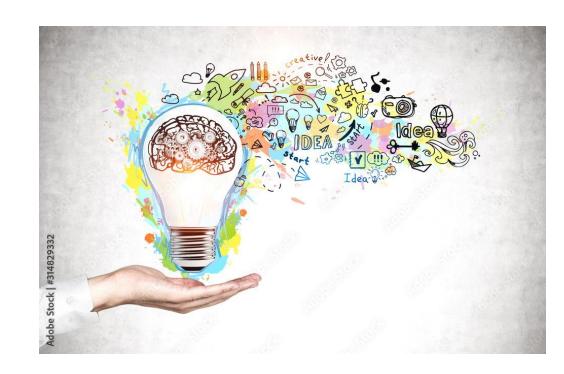
Bridge Data Validations

- SQL
 - Elements vs Bridge Attributes
 - Element CS vs Component Rating
 - Element Quantity vs Bridge Attributes
- Dashboards
 - Load Rating
 - Condition Flags
- On Save Validations
- If you check it, you need to fix it

•	
Posting / Closing Issues	0
Posting Recommended	0
Structure Should be Posted	0
Structure Should be Closed	0
oad Rating Issues	6
Assigned Rating Not Applicable	0
Built/Rebuilt > 2010 & NOT LRFR	2
Built/Rebuilt/Overlay > 1993 & ASR	0
Item 64F < 22T	0
Item 64F < or = Item 66	0
Judgment Rating Not Applicable	0
NHS & ASR	0
No Rating Performed	6
Poor Condition & Rating Does Not Represent Current Condition	0

and bata county located	Count
Item 64F or Item 66 = 0 with No Temp Condition	0
Load Rating Methods Inconsistent	0
Load Rating Method No Longer Accepted	0
Null Rating Value	4
Null Rating Value

Dashboards - Condition Flags

Structure Inventory Summary	Count	Structure Condition Summary	Count
Total No. of Structures Highway (NBI) Structures greater than 20'	5,916 4,504	Good/Fair (5 or Greater)	5,497
Highway Structures less than 20' Rail Road Structures (X)	1,117 125	Highway included in NBI Non NBI Structures (<20, RR, Ped, etc.)	4,217 1,280
Pedestrian Structures (P)	157	<u>Poor (4)</u>	356
Other Non-Highway Structures (V, Plaza) Additional Bridge Inventory Information	13	Highway included in NBI Non NBI Structures (<20, RR, Ped, etc.)	254 102
Posted Structures	25	Serious/Critical (3 or less)	55
Closed Structures Fracture Critical Structures	20 82	Highway included in NBI Non NBI Structures (<20, RR, Ped, etc.)	33 22
Scour Critical Structures	479	Unrated Structures	8
Scheduled/Under Construction (S, G)	136	Highway included in NBI Non NBI Structures (<20, RR, Ped, etc.)	0 8

SD/FO Summary	Count
*Structurally Deficient *Functionally Obsolete *Non-Deficient Structures *No Current SD/FO Rating	287 1,021 3,195 229
NBI Condition - Goals Summary	Pct.
*Good/Fair (5 or Greater) Freeway Non-Freeway	93.6% 94.1% 92.9%
*Poor/Serious/Critical (4 or Less) Freeway Non-Freeway *Good NHS Deck Area *Fair NHS Deck Area	6.4% 5.9% 7.1% 20.1% 73.4%
*Poor NHS Deck Area *Applies ONLY to Highway Structures > 20'	6.6%

Integrity Errors	Count
Duplicate Bridge ID check	0
Duplicate Parameters Check	0
Duplicate Parameter Null Values	0
Duplicate Param Order Values	1
Element Foreign Key Violation	0
